Peugeot 5008 – 2010-2017 Our Ref HO506

2 variations available, please take time to consider which of the 2 most suits your requirements.

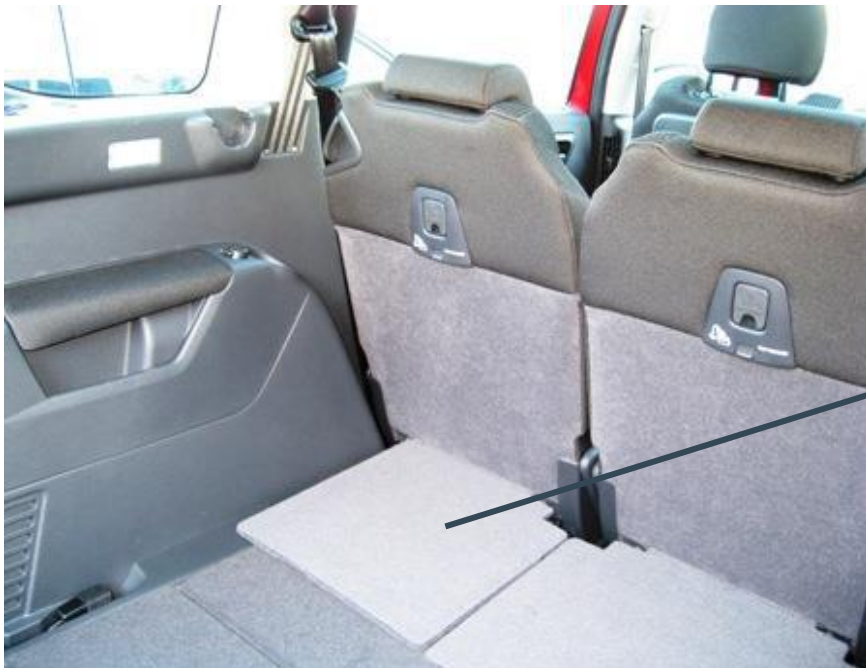
I: BACK

Row 2 seats slid as far back to the tailgate

The 3rd row foot well covers must be down to prevent heavy loads putting tension onto the liner over the recessed foot well

These will prevent the use of the 2 tie down "D" rings positioned under the cover.

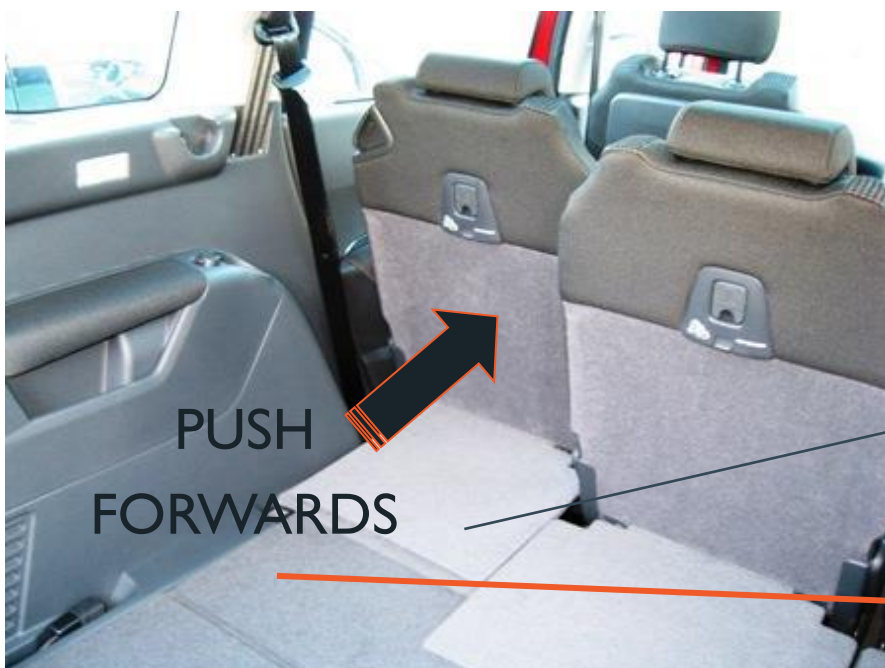
I: FORWARD

Row 2 seats slid as far forward to the front of the vehicle

The 3rd row foot well covers must be down to prevent heavy loads putting tension onto the liner over the recessed foot well

The 2 tie down "D" rings are left exposed. These are sometimes used with dog guards or load retaining nets.
